# Manhole Inspection Summary

Manhole # S45C2\_036MH

Insp Date: **12/28/07 7:53 AM**

**Location** Address: **1503 Sycamore St**

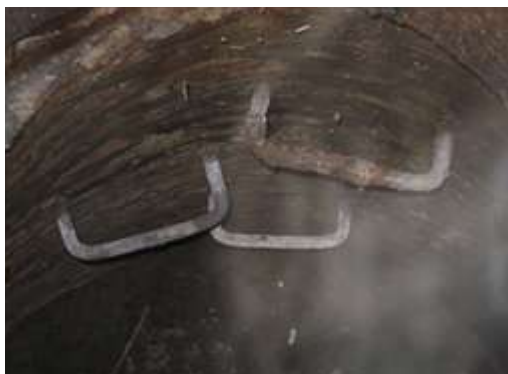
Steps

Count: **3** Missing: **0** ☐ Corroded

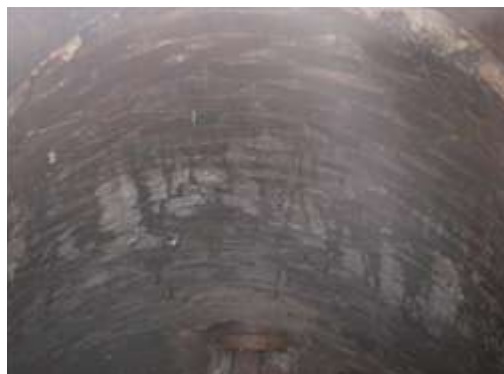
Defect 2

Infiltration: ☐ None ☒ **Joint** ☐ Cracks ☐ Mortar ☐ Roots ☒ **Wall**

Wall

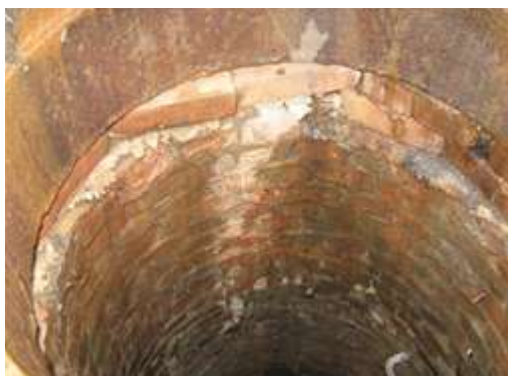
Defect 1

Condition: ☐ Sound ☐ Cracked ☐ Root Intrusion ☒ **Loose Brick** ☐ Deteriorated

Loose Bricks

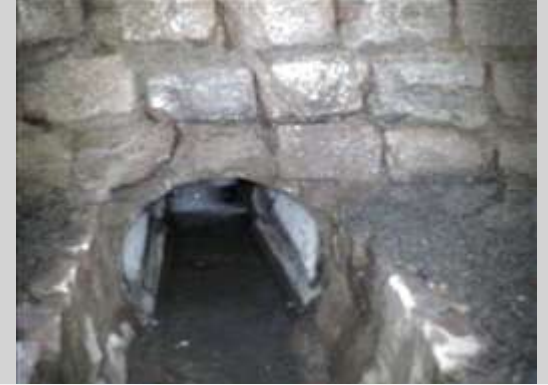
12 O'Clock Outflow

Pipe Height: **8.4** (in.) Rod and Bar (Angled)  
Pipe Material: **Clay** ☐ Pipe Lined  
Invert Depth: **7.91** (ft.) Flow Characteristics: **None**  
Deposits: ☒ None ☐ Mud ☐ Sludge ☐ Debris ☐ Grease  
Silt Depth: (in.) Deposits Extent:  
Infiltration: **None** Pipe Seal Cond: **Sound**

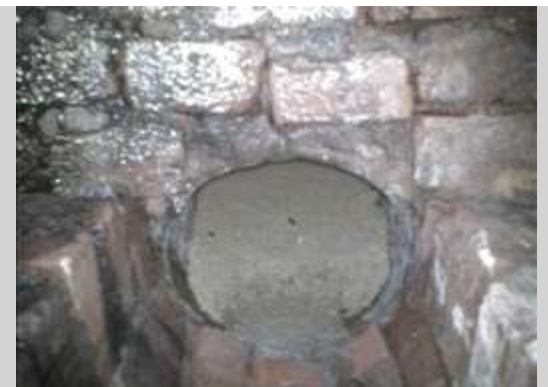
6 O'Clock Inflow

Plugged line

Connects To: **Stub connection / abandoned**

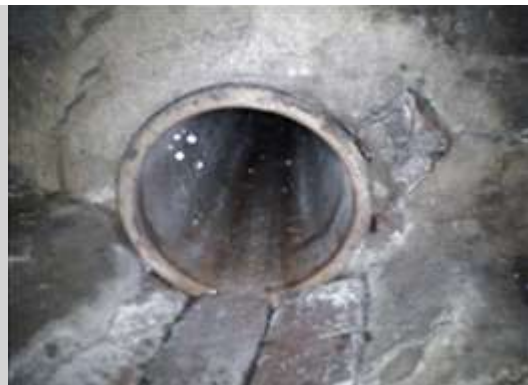
8 O'Clock Inflow

Pipe Height: **7.2** (in.) Rod and Bar (Angled)

Pipe Seal Cond: **Sound**
